Microstructure Degradation after Prolonged Exploitation of Heatresistant Steel 14mov6-3

Abstract: Metallographic testing of material microstructure represents important method for characterization of material behavior. In case of heat resistant steels that are used for steam lines and boiler components of thermal power plants for a long period of service time, under the influence of mechanical and thermal loads their microstructure will be changed. As a result, it will have significant influence on mechanical properties of such material. Metallographic testing can be used for following of microstructure evolution

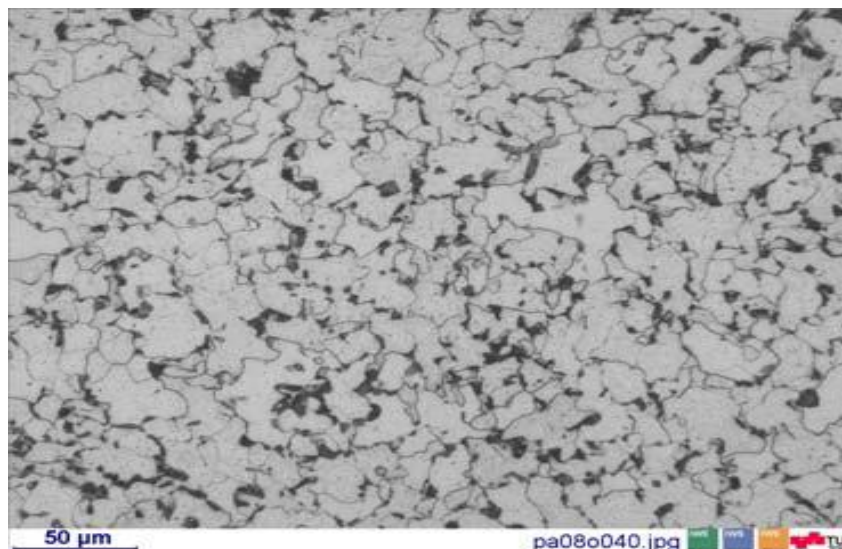
Figure 1. Microstructure of virgin steam line material 14MoV6-3, magnification 200x, [6]

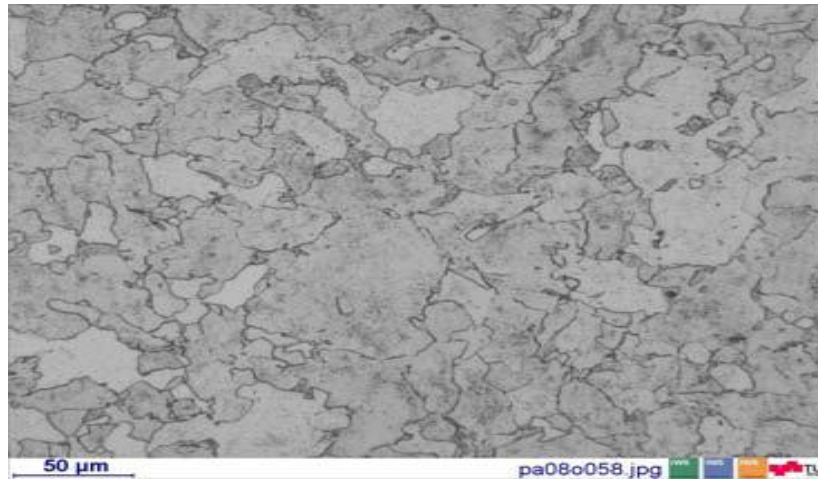
Figure 2. Microstructure of exploited steam line material 14MoV6-3, magnification 200x, [6]

The final structure image after prolonged exploitation is ferrite with rather homogeneously distributed precipitations inside grains and chains of the significant amount of precipitations on their boundaries, [7]. Results of microstructure investigation that are presented in this paper mainly can confirm previous facts, but in addition to mentioned microstructure evolution, there is also a significant growth of ferrite grain size after long-term operation at elevated temperature.

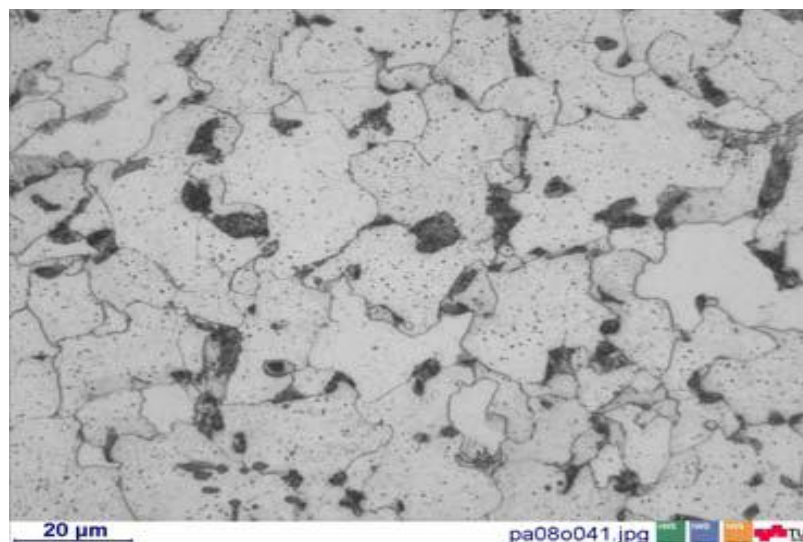
Figure 3. Microstructure of virgin steam line material 14MoV6-3, magnification 500x, [6]

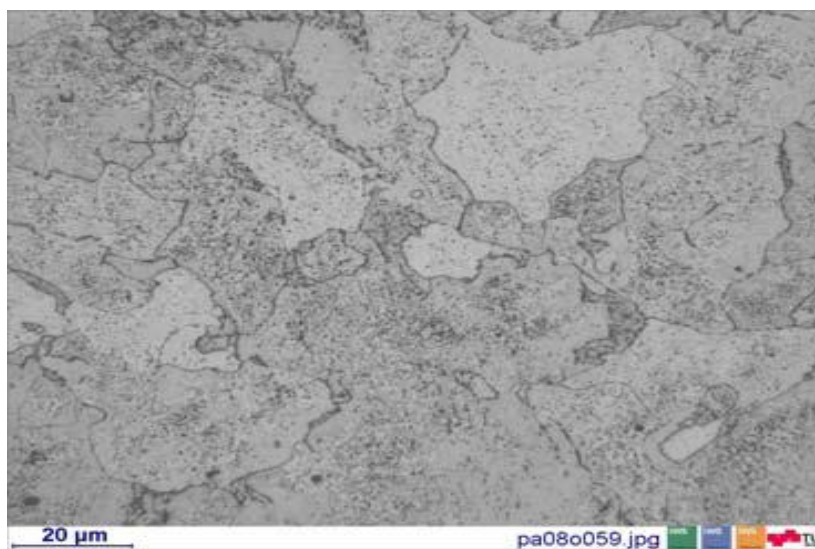
Figure 4. Microstructure of exploited steam line material 14MoV6-3, magnification 500x, [6]

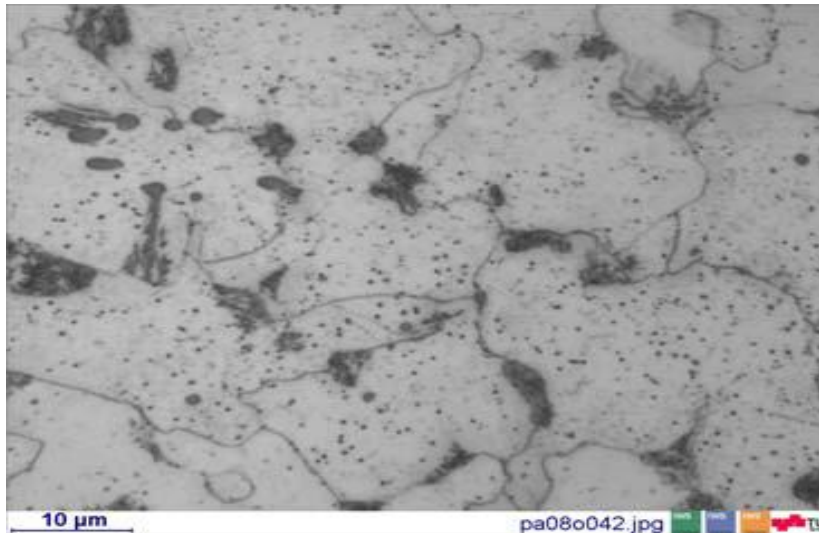
Figure 5. Microstructure of virgin steamline material 14MoV6-3, magnification 1000x, [6]

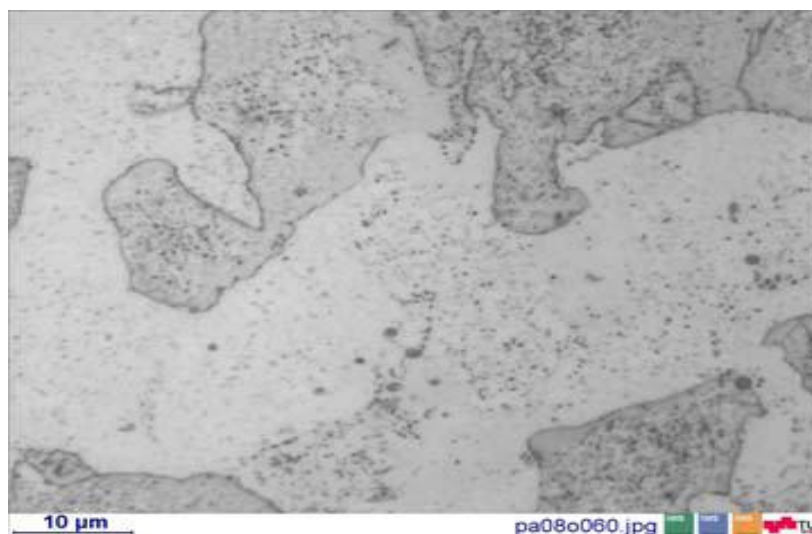
Figure 6. Microstructure of exploited steamline material 14MoV6-3, magnification 1000x, [6]
