# Microstructure Analysis of Inlet and Exhaust Valves used in LPG fueled Retrofitted Spark Ignition Engines

**ABSTRACT:** Mechanically operated poppet valves are used, both as inlet and exhaust, for most conventional automotive engines in passenger cars. These valves are subjected to high temperatures throughout their operating cycle. A valve originally designed for a gasoline engine, when used for an LPG fueled retrofitted engine, goes through considerable mechanical damage, corrosion, erosion, wear and tear. It also demonstrates significant changes in its microstructure. This investigation focused on microstructure analysis and quantitative metallography of such inlet and exhaust valves using Atomic force microscopy (AFM) technique. The surface morphology of the valve material was studied and AFM measurements were used for quantitative characterization of the structure as also to gain useful information about crystallographic orientation of individual grains, the formation of cracks, identification of potential crack initiation and fracture sites, etc. A comparative evaluation of microstructure of worn - out valves with new valves was also carried out.

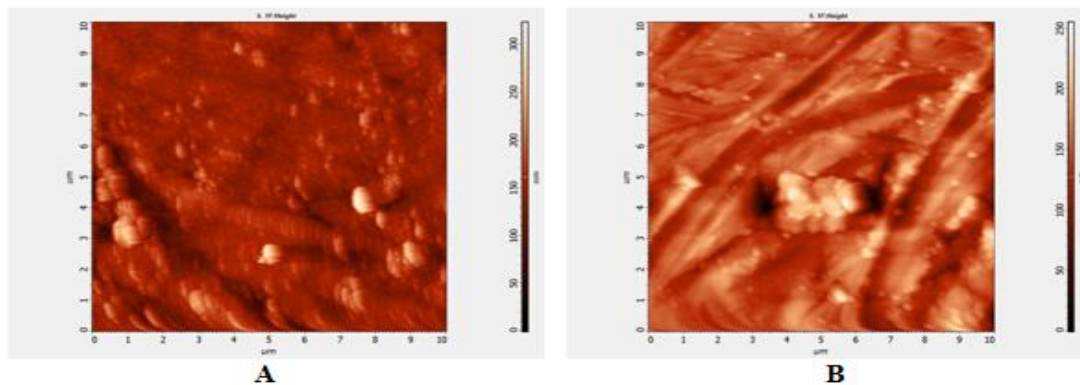
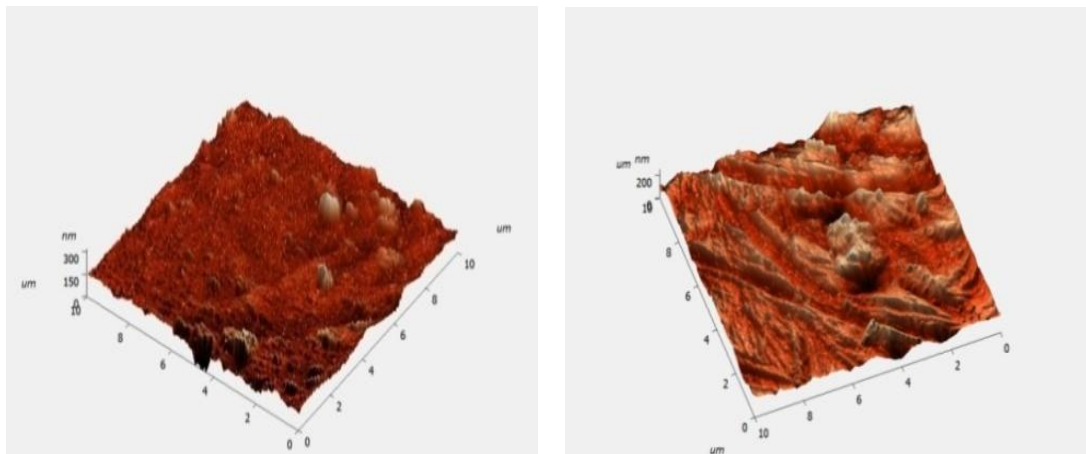
Some representative images for inlet and exhaust valves are shown below (Fig. 2 & 3). The image for the failed exhaust valve clearly shows the presence of a significantly large number of secondary particles that could well be silicates, oxides and / or carbides. The crack initiation sites are likely to surface across all projections. The effect of thermal stresses and mechanical failure causing agents is visible through material deformation and material drifting. The image for a new exhaust valve shows the inclusion of an abrasive particle. Some finishing patterns that are so typical of the manufacturing operations employed are also visible. The image for a failed / worn – out inlet valve exhibits pronounced effects of high chemical abrasion. A number of voids scattered across the section are an indication of a thermal shock wave and accompanying thermal stresses. The changes in the surface and its structure are an indication of the effect of temperature and chemical agents. The cracks at some locations may also be attributable to the escaping out of entrapped gases that result in appearance of secondary structures. The image for a new inlet valve is quite similar to the one for an exhaust valve with a number of minute granules distributed in a more or less uniform manner.

Figure 2: AFM images (2D & 3D) for worn – out exhaust valve (A, C) and new exhaust valve (B, D)

The 2D images, corresponding 3D images and magnitudes of statistical descriptors (Table I) for failed and new inlet and exhaust valves provide useful information about the existence of surface asperities, grain sizes and crack propagation. The peak to peak value is the maximum for the failed exhaust valve which indicates that this valve has suffered a significant bit of mechanical damage which, to a large extent, is attributable to the high temperature the valve encounters in an LPG engine. The peak to peak values are less for inlet valves as they are subjected to lesser thermal gradient and lower highest temperature. The average roughness values exhibit exactly the opposite patterns for exhaust and inlet valves. The average roughness value for the failed inlet valve is almost double the value for the new inlet valve which is an indication of bulk surface deformation under thermal and cyclic stresses

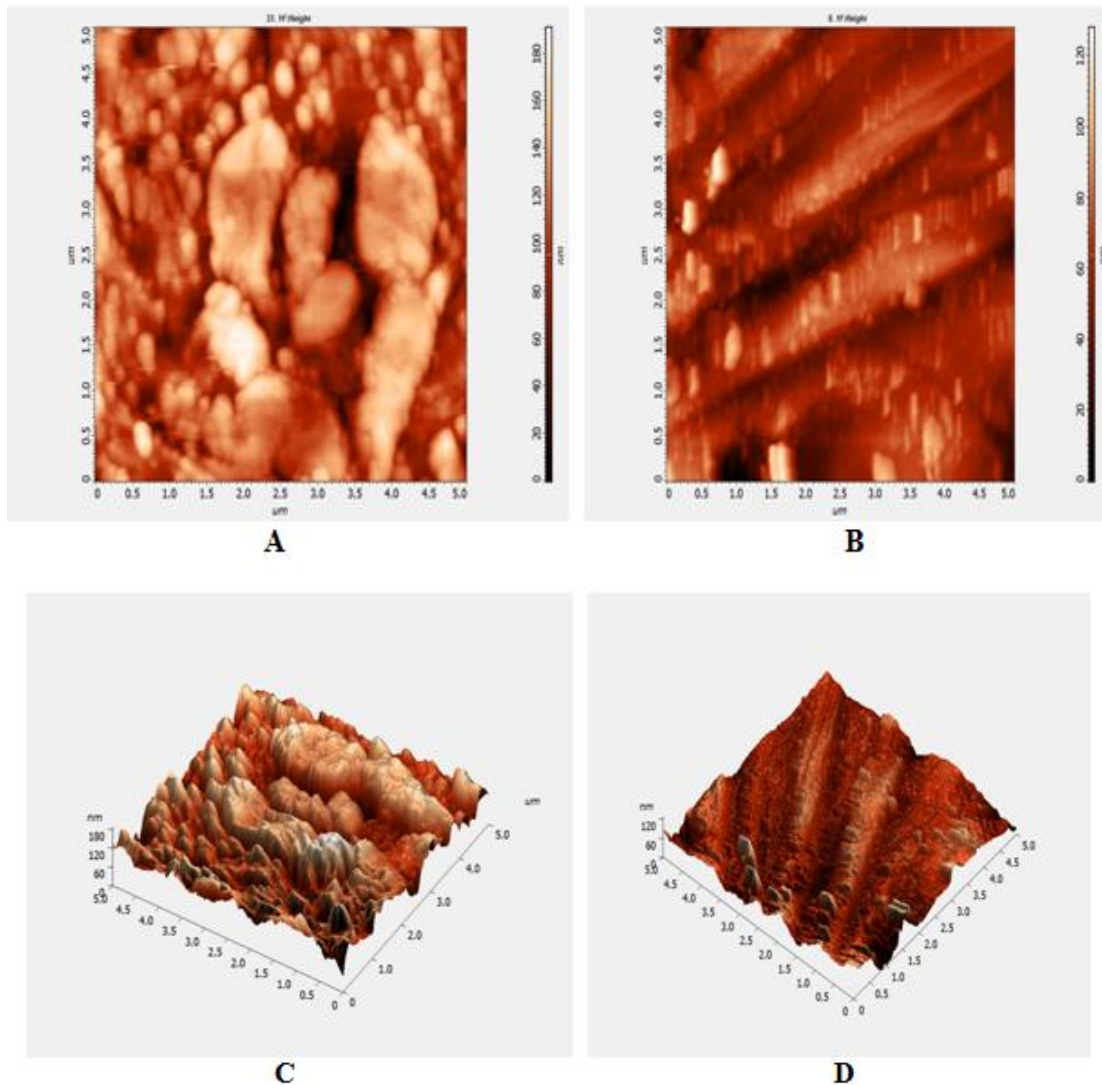
Figure 3: AFM images (2D & 3D) for worn – out inlet valve (A, C) and new inlet valve (B, D)
