Retrofitting and Strengthening of Damaged Reinforced Concrete Columns Using Steel Angles Wrapped with Steel Wire Mesh

Abd-ELhamed, M. K.¹, EZZ-Eldeen, H. A.²
1 and 2 Faculty of Engineering, Al – Azhar University, Cairo, Egypt

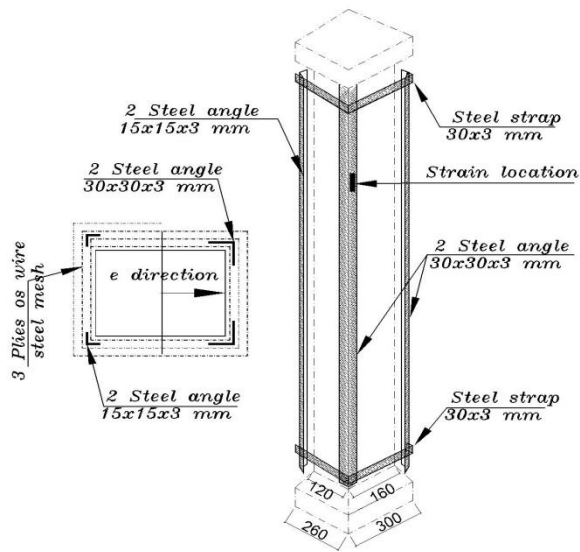
Figure 1 specimens and strengthened details

- Wrapped columns with only three plies expanded steel wire mesh wrapped with two steel straps 30×3 mm at the column top and bottom.
- Four vertical steel angles were used at the corners of column wrapped with three plies expanded steel wire mesh. Two angles $30 \times 30 \times 3$ mm were placed in eccentricity direction and two angles $15 \times 15 \times 3$ mm were placed in the reverse direction as shown in figure 1.

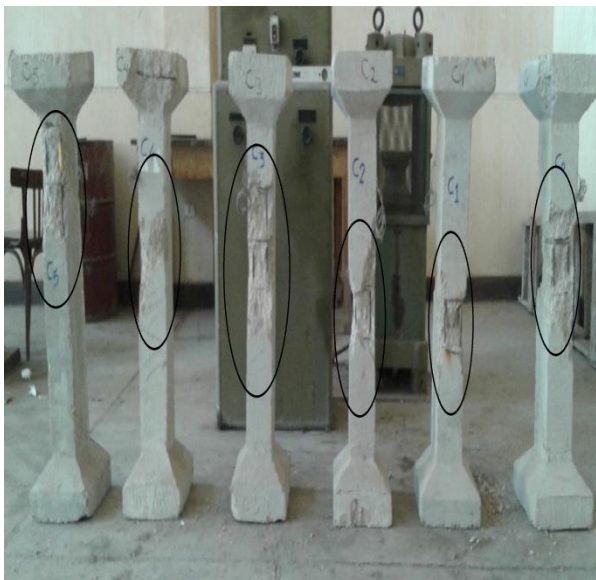
Figure 3 Specimens after testing before retrofitting.

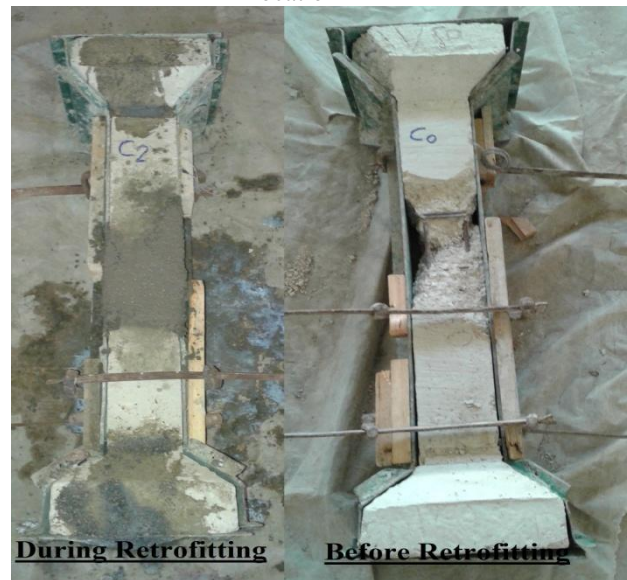
Figure 4 Details of retrofitting columns with Grout mortar.

The Cetorex grout mortar with high-strength, low or non-shrink is used for replacing the damaged concrete part and restore specimens dimension as shown in figure 4. Special attention was made to achieving a good bond between the new and the existing concrete. The specimens were cured with wet sackcloth for seven days. One of the specimen was strengthened with three plies steel wire mesh only and tested under eccentricity $e/t= 0$. In addition, one specimen was strengthened with four vertical steel angles 30x30x3mm at each column corners after the column wrapped with one plie steel wire mesh and then wrapped with two plies steel wire mesh as shown in figure 5 and then tested under eccentricity $e/t= 0$. The other four specimens were wrapped with one plie steel wire mesh then placing the vertical steel angles in each column corners and then wrapped with two plies of steel wire mesh. Two angles 30x30x3mm were placed in the eccentricity direction and other two angles 15x15x3mm were placed in the reverse direction. All specimens were wrapped with two steel straps 30x3 mm at the column top and bottom. The Strain Gauges were mounted on the vertical steel angle in the compression side. Thereafter, all the specimens were plastered with rich mix mortar cement sand ratio of 1:2.5 with water-cement ratio = 0.55 as shown in figure 6. In order to improve workability, super plasticizer was used. All columns were cured for 28 days from the date of casting of jacketing. All casted specimens were kept in a dry place for a few hours for attaining surface dry condition. Thereafter, all columns were tested using hydraulic compression testing machine of capacity 2000 KN at the Material laboratory of Al-Azhar University as shown in figure 7. The different eccentricities were controlled by column head steel plates as shown in figure 8.

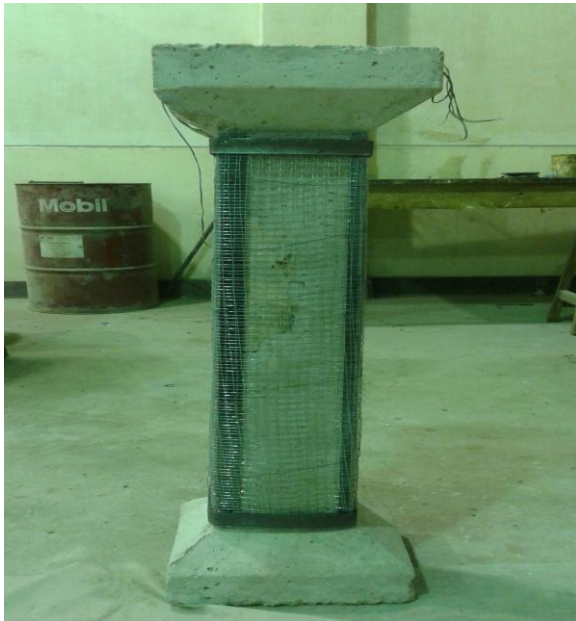
Figure 5 Details of strengthened column with 4 angles and 3 plies wire mesh

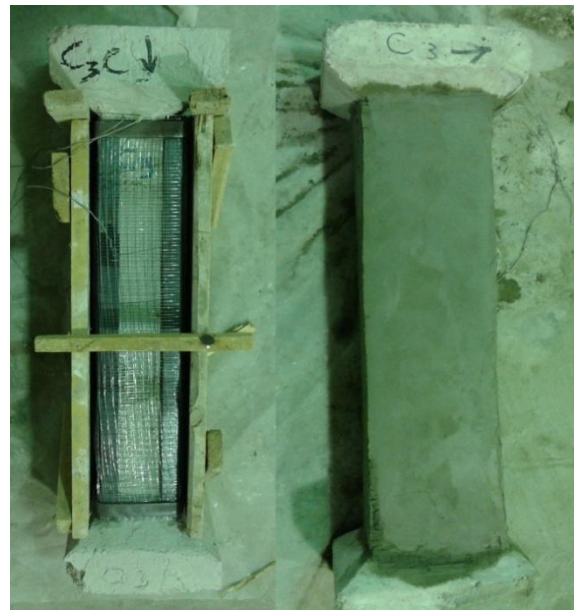
Figure 6 Form shape used for cement mortar

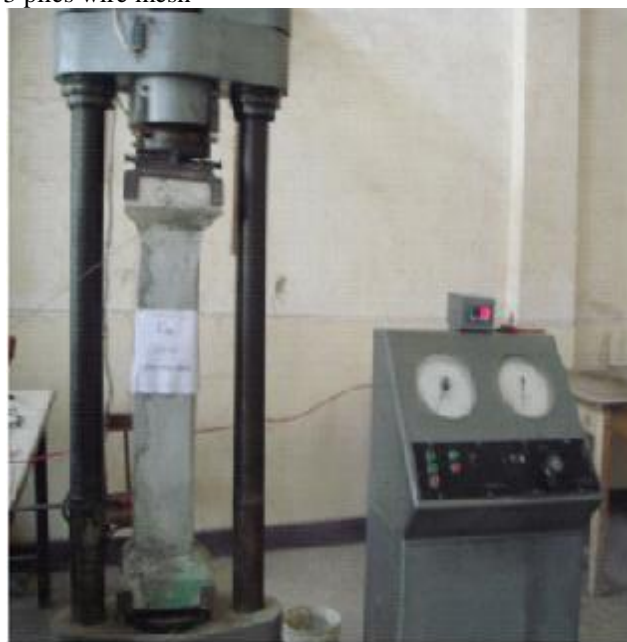
Figure 7 Test machine and test setup

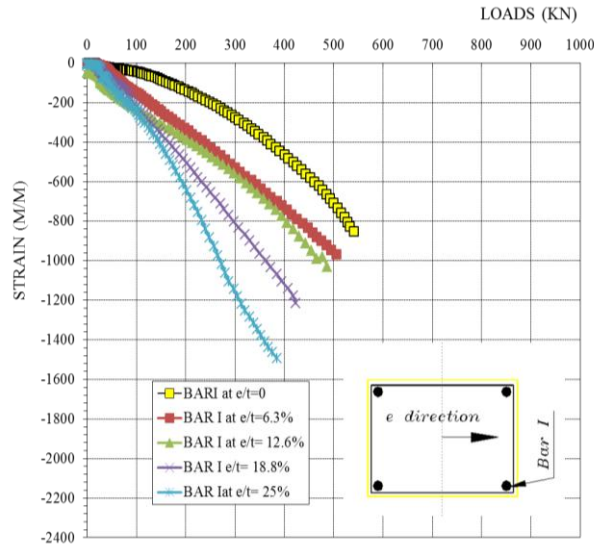
Figure 9: The relationship between load and longitudinal strain for Bar I at $e/t= 0\%$ to 25% (Control Column-non strengthened)

Figure 9 shows the relationship between the load and longitudinal strain. For the internal vertical steel bar in the eccentricity direction BAR I (no retrofitting and no strengthened) Due to increasing eccentricity, the strain in BAR I increases from 820micro strain to 1500 micro strain while the load decreased from 541 KN to 385 KN.

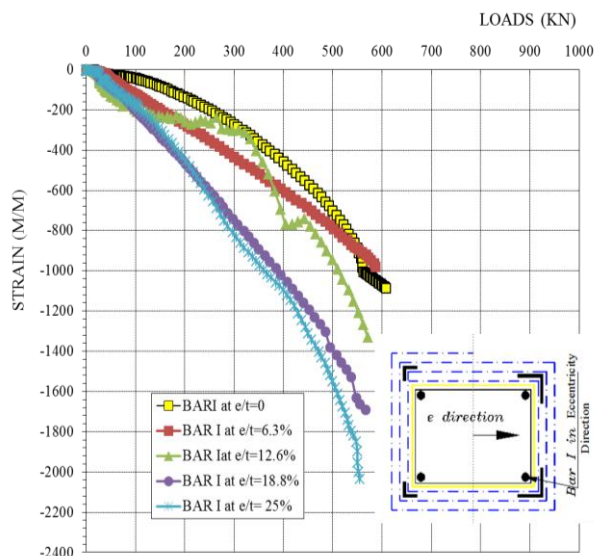
Figure 10: The relationship between load and longitudinal strain for Bar I at $e/t= 0\%$ to 25% (4angles&3 plies wire mesh)

- Figure 10 shows the relationship between the load and longitudinal strain. For the internal vertical steel bar in the eccentricity direction BAR I (after retrofitting and strengthened with 4angles&3 plies wire mesh) Due to increasing eccentricity, the strain in BAR I increases from 1100micro strain to 2100 micro strain while the load decreased from 608 KN to 555 KN.

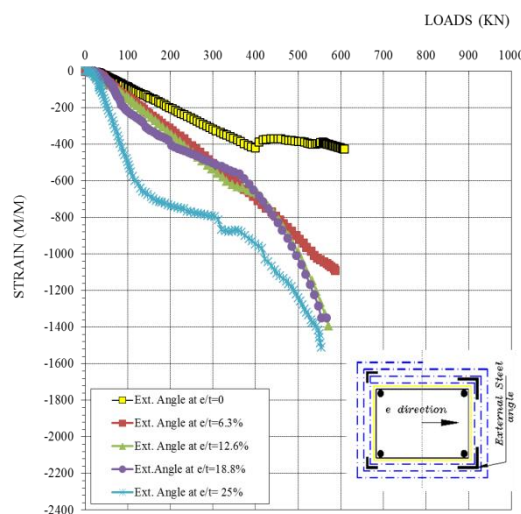
Figure 11: The relationship between load and longitudinal strain for angle at e/t= 0% to 25% (4angles&3 plies wire mesh)

- Figure 11 shows the load-strain relationship between the load and longitudinal strain. For the external vertical steel angles in the eccentricity direction (after retrofitting and strengthened with 4angles&3 plies wire mesh) Due to eccentricity, the strain in the external angles increases from 400micro strain to 1500 micro strain while the load decreased from 608 KN to 555 KN.

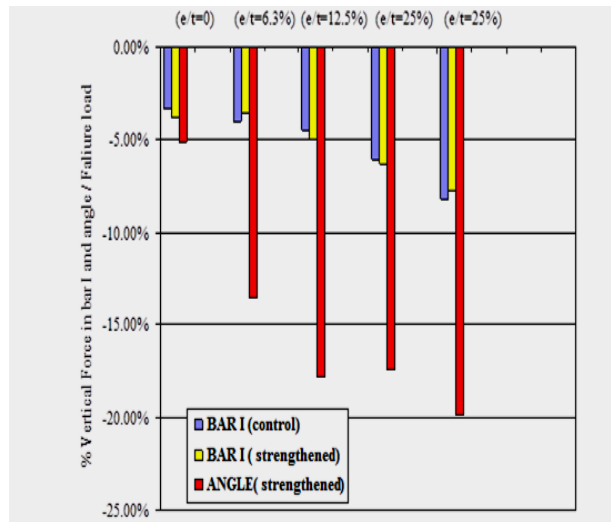
Figure 12: The relationship between forces in a vertical steel bar I and steel angle with respect to control column at failure loads

- Figure 12 shows the relationship between the forces in a vertical steel BAR I (before and after strengthened) as well as steel angles with respect to control column at failure loads and increasing eccentricity from e/t= (0% to 25%). The percentage of forces in the steel bars at the eccentricity direction increased from 4% to 8.2 % of the failure load with eccentricity increased from e/t= 0% to 25% in case of control columns. However, the percentage of forces on the bar at eccentricity direction increased from 3.8% to 7.8 % of the failure load with eccentricity increased from e/t= 0% to 25% in case of strengthened columns. The percentage of forces in the vertical steel angles used in the strengthening techniques found to be in the range of 5.2% to 20 % of the failure load.

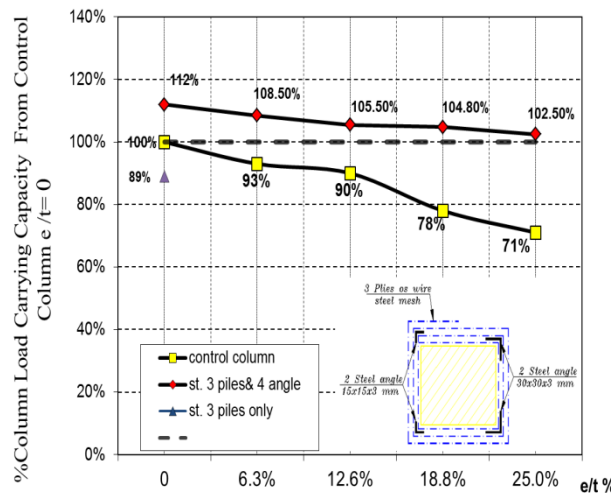
Figure 13: The relationship between % column load carrying capacity of control ($e=0$) and percentage of eccentricity for (control and strengthened column)

- Figure 13 shows the relationship between percentage column load carrying capacity control (e/t=0) and percentage of eccentricity for (control and strengthened columns). The column strengthened with three plies steel wire mesh only could not reach the ultimate loads of control column. The ultimate load of column was found to be 89% of the original ultimate load. The columns strengthened with four steel angles and wrapped with three plies steel wire mesh gives an increase in the load carrying capacity from 102.5% up to 112%.

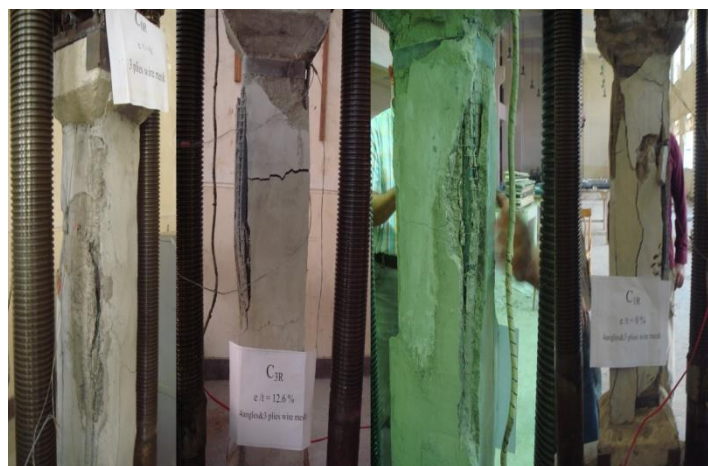
Figure 14: Failure Modes of Strengthened Columns

- Figure 14 shows the failure mode of columns under different eccentricities. The failure mode of the control reinforced concrete columns was brittle failure while strengthening with steel wire mesh jacket changed failure mode to be ductile.
